**RE: Summary Report of Preliminary Site Investigation Activities
Weld County, Colorado**

This letter report summarizes the site investigation field activities recently performed by Tetra Tech at the Pratt Property in Weld County, Colorado (the Property). A summary of the proposed scope of the site investigation activities is listed below:

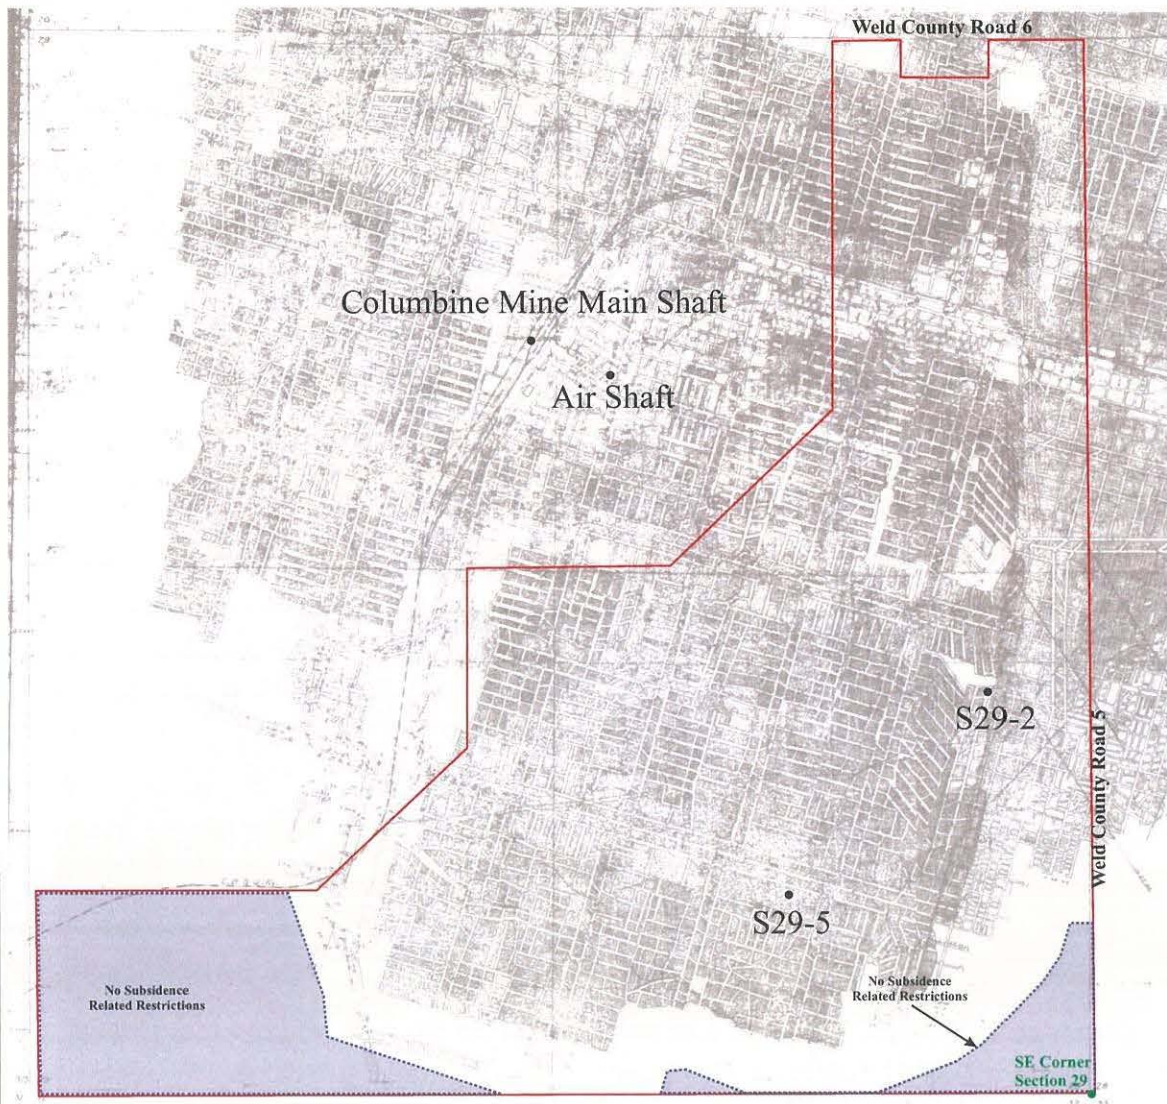
Mine Map from the Colorado Geological Survey, Columbine Mine

- Western Environment and Ecology, Inc. Boring location

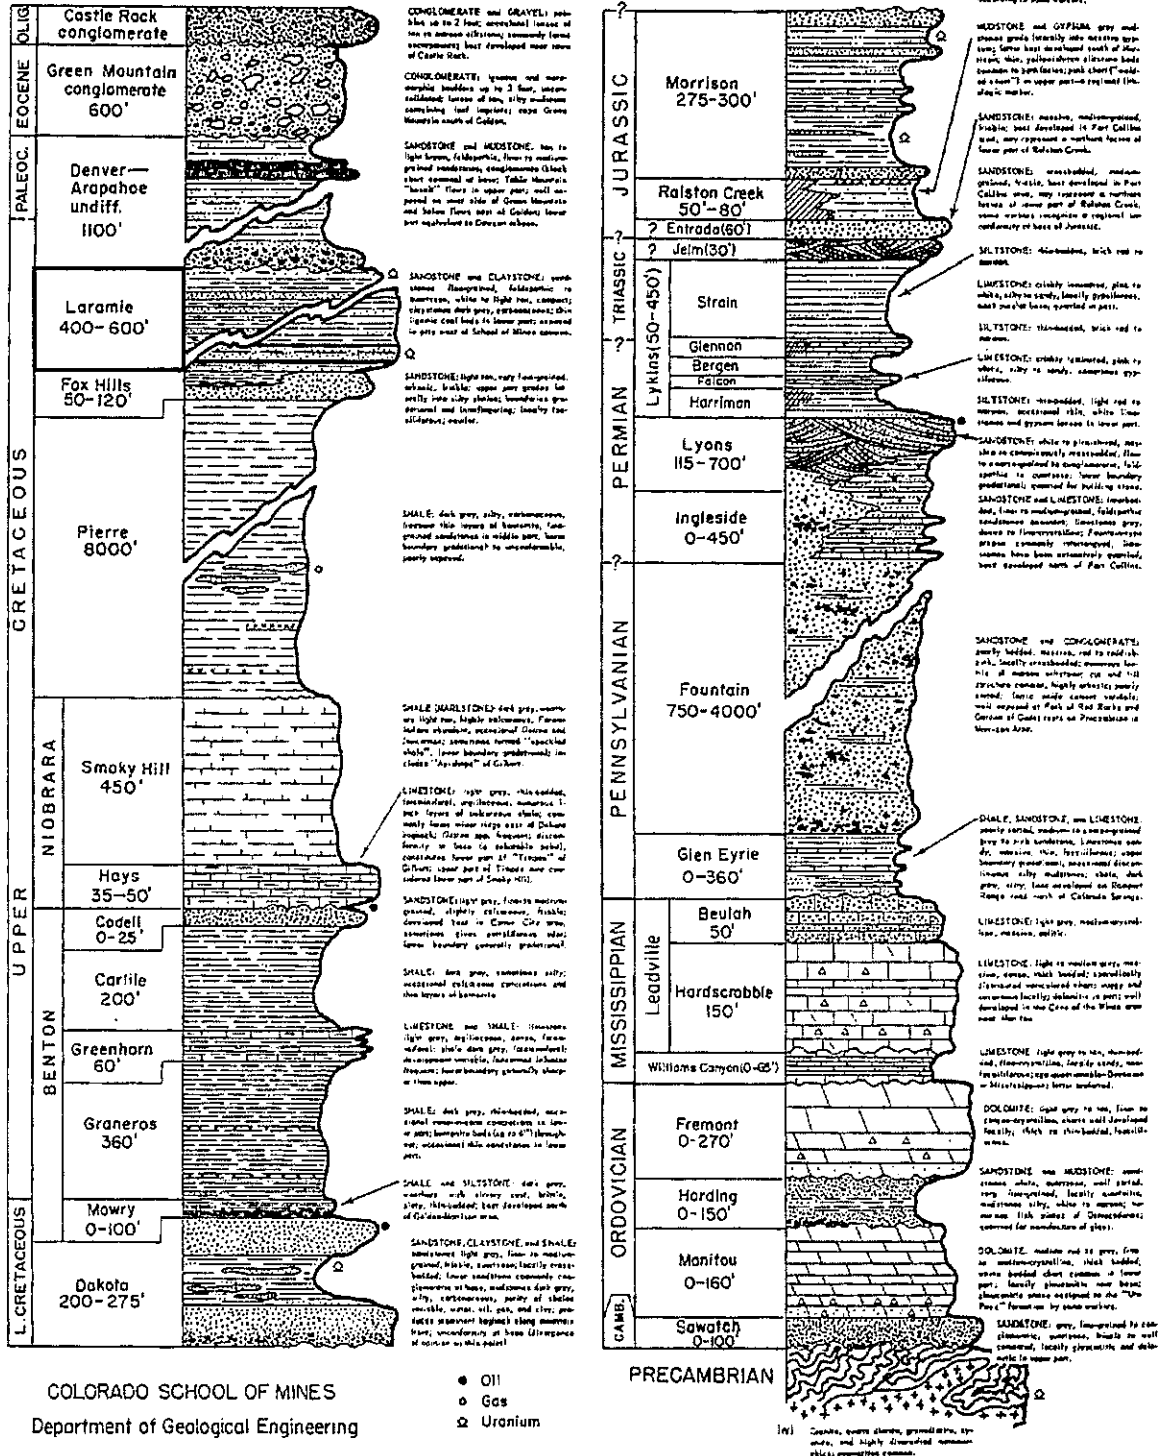
GENERALIZED COMPOSITE
STRATIGRAPHIC SECTION
FRONT RANGE OF COLORADO

The Laramie Formation, which directly underlies the site is predominantly a fresh water deltaic sequence, consisting of clays, sands, silts and coals (Figure 5). The lower portion is approximately 100 feet thick and is composed of sandstones, sandy shales, claystones, and coal beds. These coals have been economically mined in the past. The upper unit has a thickness of approximately 600 feet and is made up of mostly clay shales, very fine sandy shales, and lenticular beds of sandstone. The shales are largely carbonaceous and in places becomes lignitic. The Laramie Formation lies comfortably on the Fox Hills Sandstone.

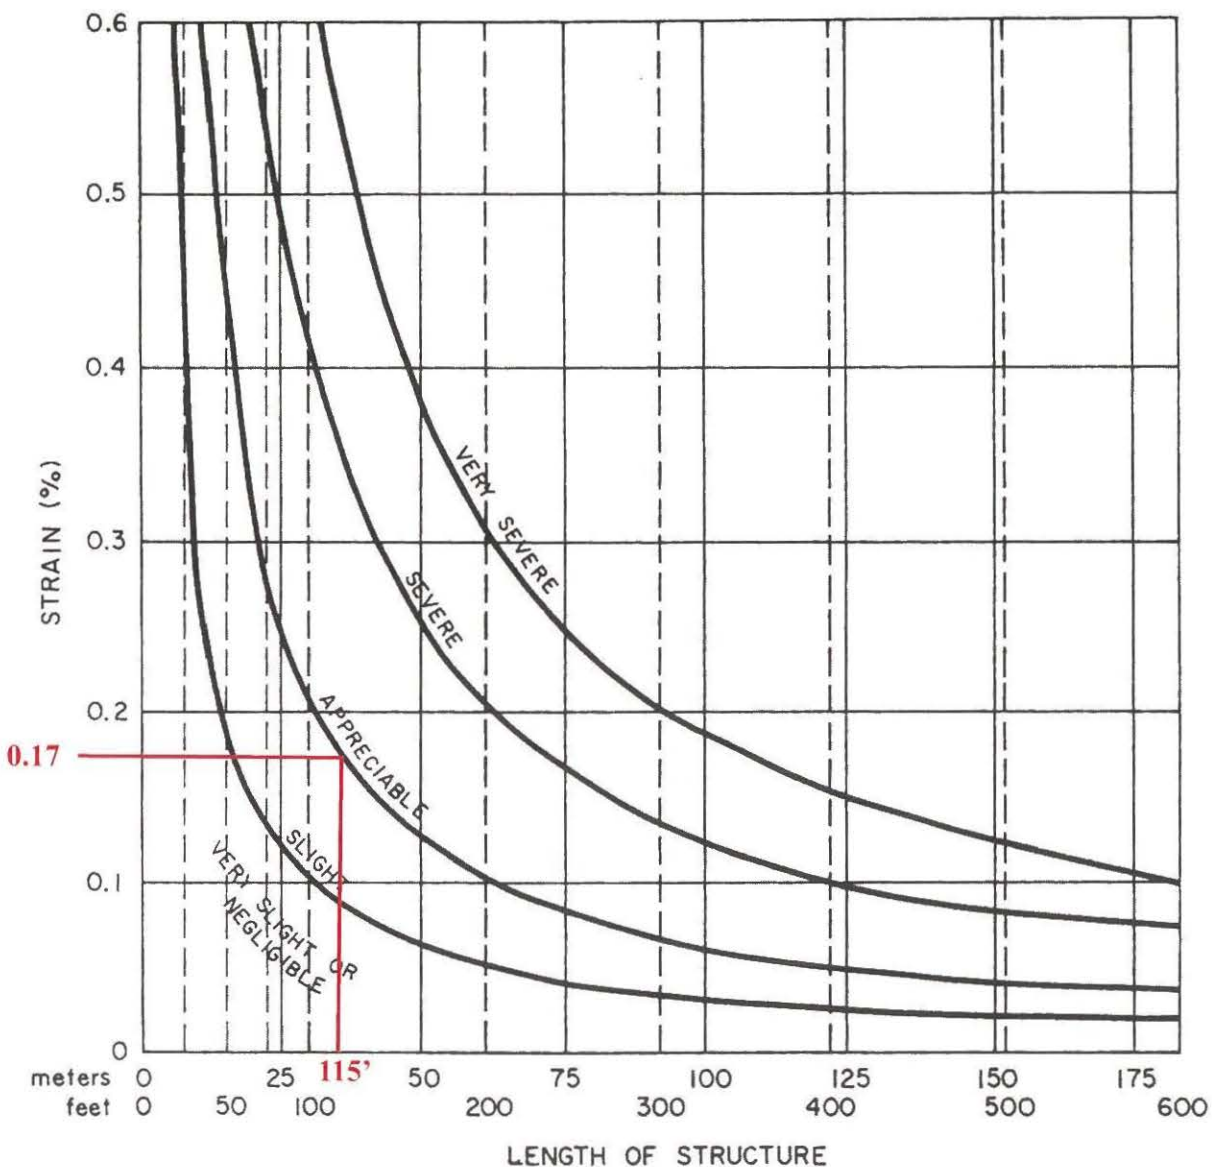
These theoretical worst case strains are in-sufficient to cause "appreciable" damage to structures or foundation segments of **115 feet or less** (Figure 5).

CLASS OF DAMAGE	DESCRIPTION OF TYPICAL DAMAGE
VERY SLIGHT OR NEGLIGIBLE	SLIGHT CRACKS SHOWING IN WALLS AND CEILINGS INSIDE BUILDINGS, BUT NOT VISIBLE ON OUTSIDE.
SLIGHT	SLIGHT CRACKS SHOWING INSIDE THE BUILDING. DOORS AND WINDOWS WILL NOT CLOSE.
APPRECIABLE	SLIGHT CRACKS SHOWING BOTH OUTSIDE AND INSIDE BUILDING. DOORS AND WINDOWS WILL NOT CLOSE. DRAINS, SEWERS, AND GAS PIPES FRACTURE.
SEVERE	DRAINS, SEWERS, AND GAS PIPES FRACTURE. OPEN FRACTURES THROUGH WALLS OF BUILDING. WINDOW AND DOOR FRAMES DISTORTED. FLOORS NOTICEABLY SLOPING, WALLS LEANING OR BULGING NOTICEABLY. SOME LOSS OF BEARING OF BEAMS ON WALLS. PORTICOES AND FLOORS BUCKLE.
VERY SEVERE	WORSE THAN ABOVE AND REQUIRING PARTIAL OR COMPLETE REBUILDING. ROOF AND FLOOR BEAMS LOSE BEARING AND WALLS LEAN BADLY AND NEED EXTERNAL SUPPORT. WINDOWS BROKEN AND DISTORTED. SEVERE SLOPES, BUCKLING AND BULGING OF ROOFS AND WALLS OCCUR.

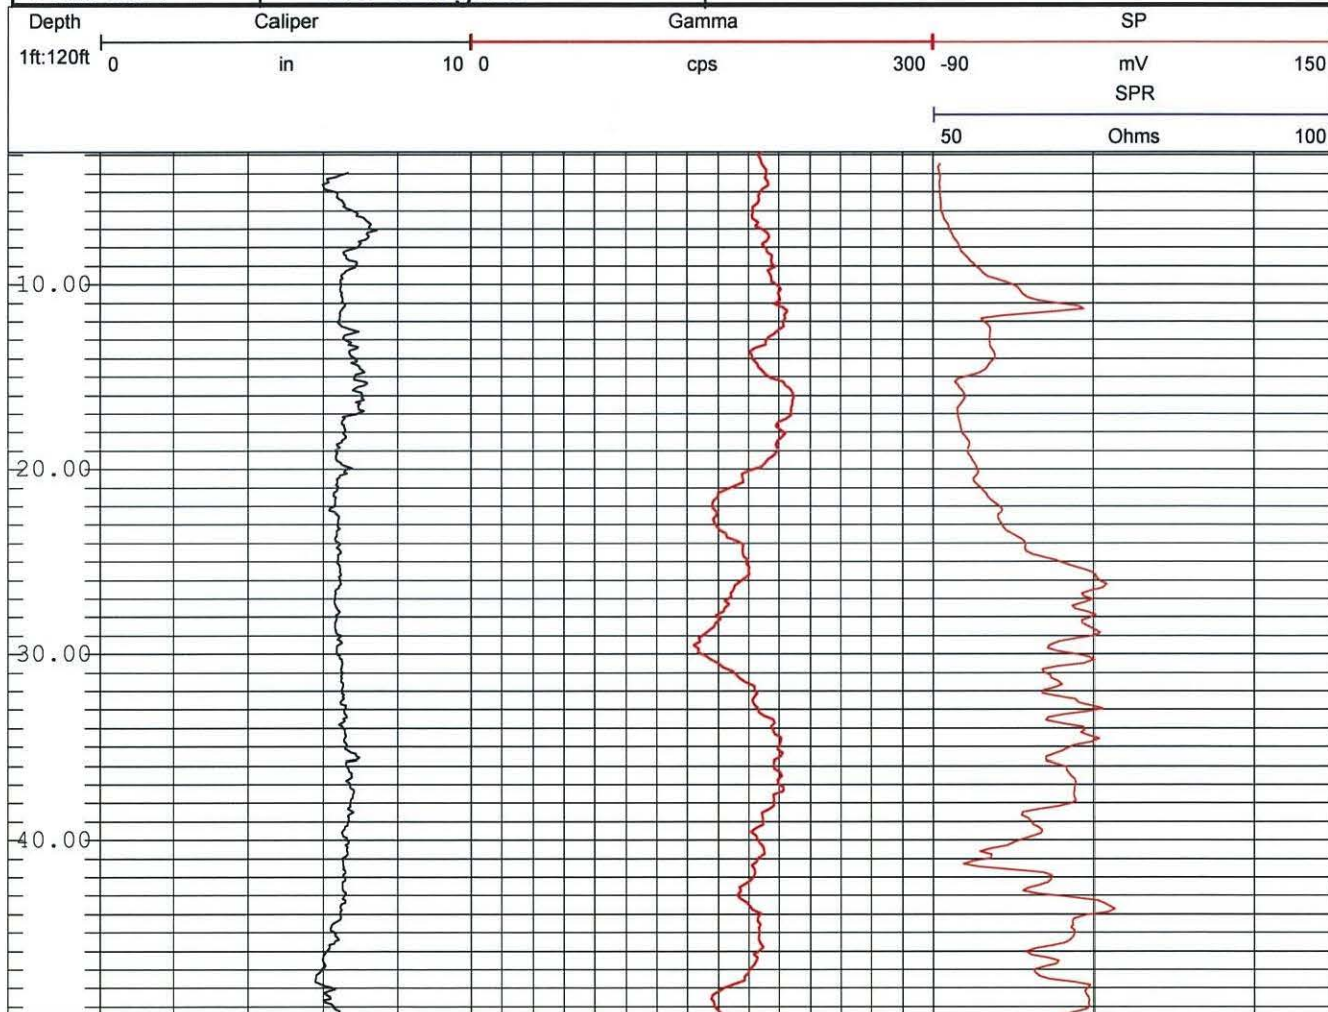
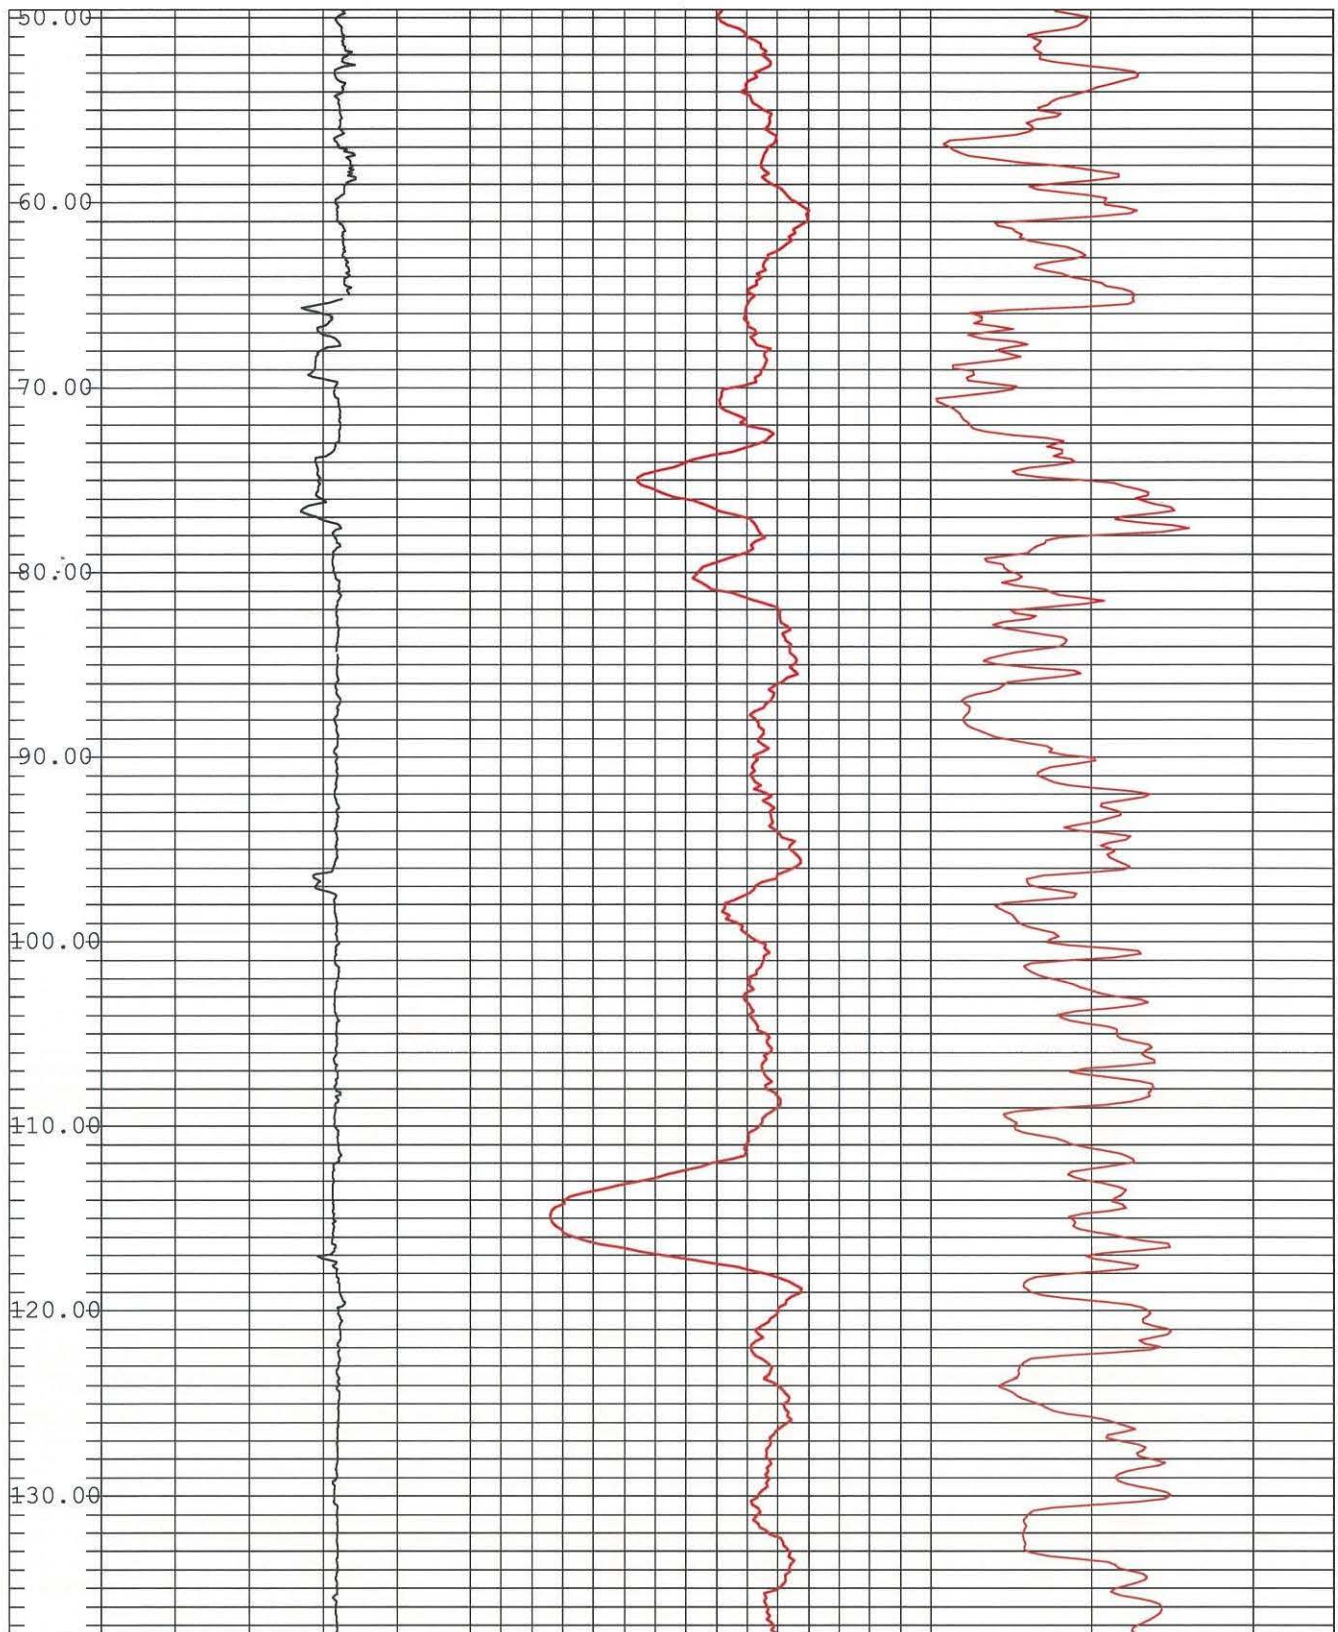
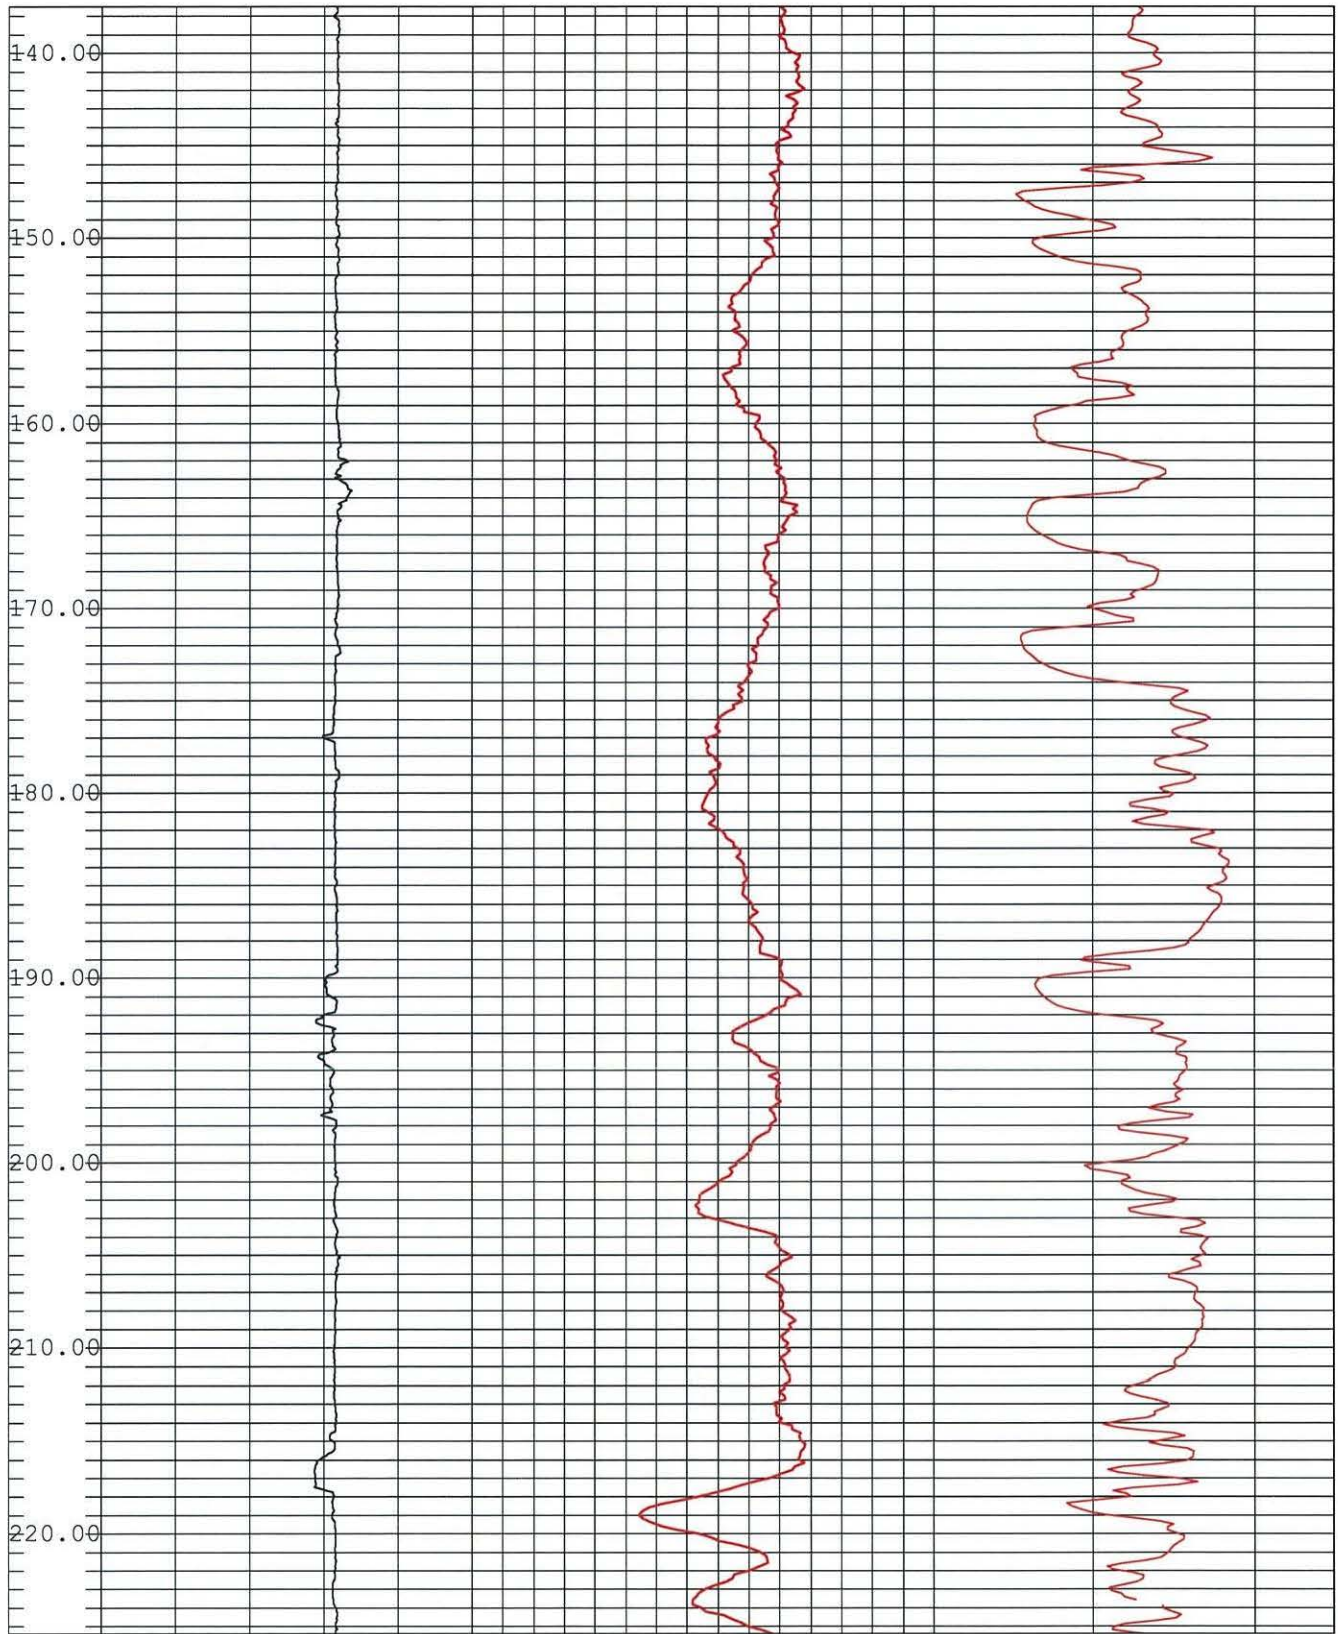
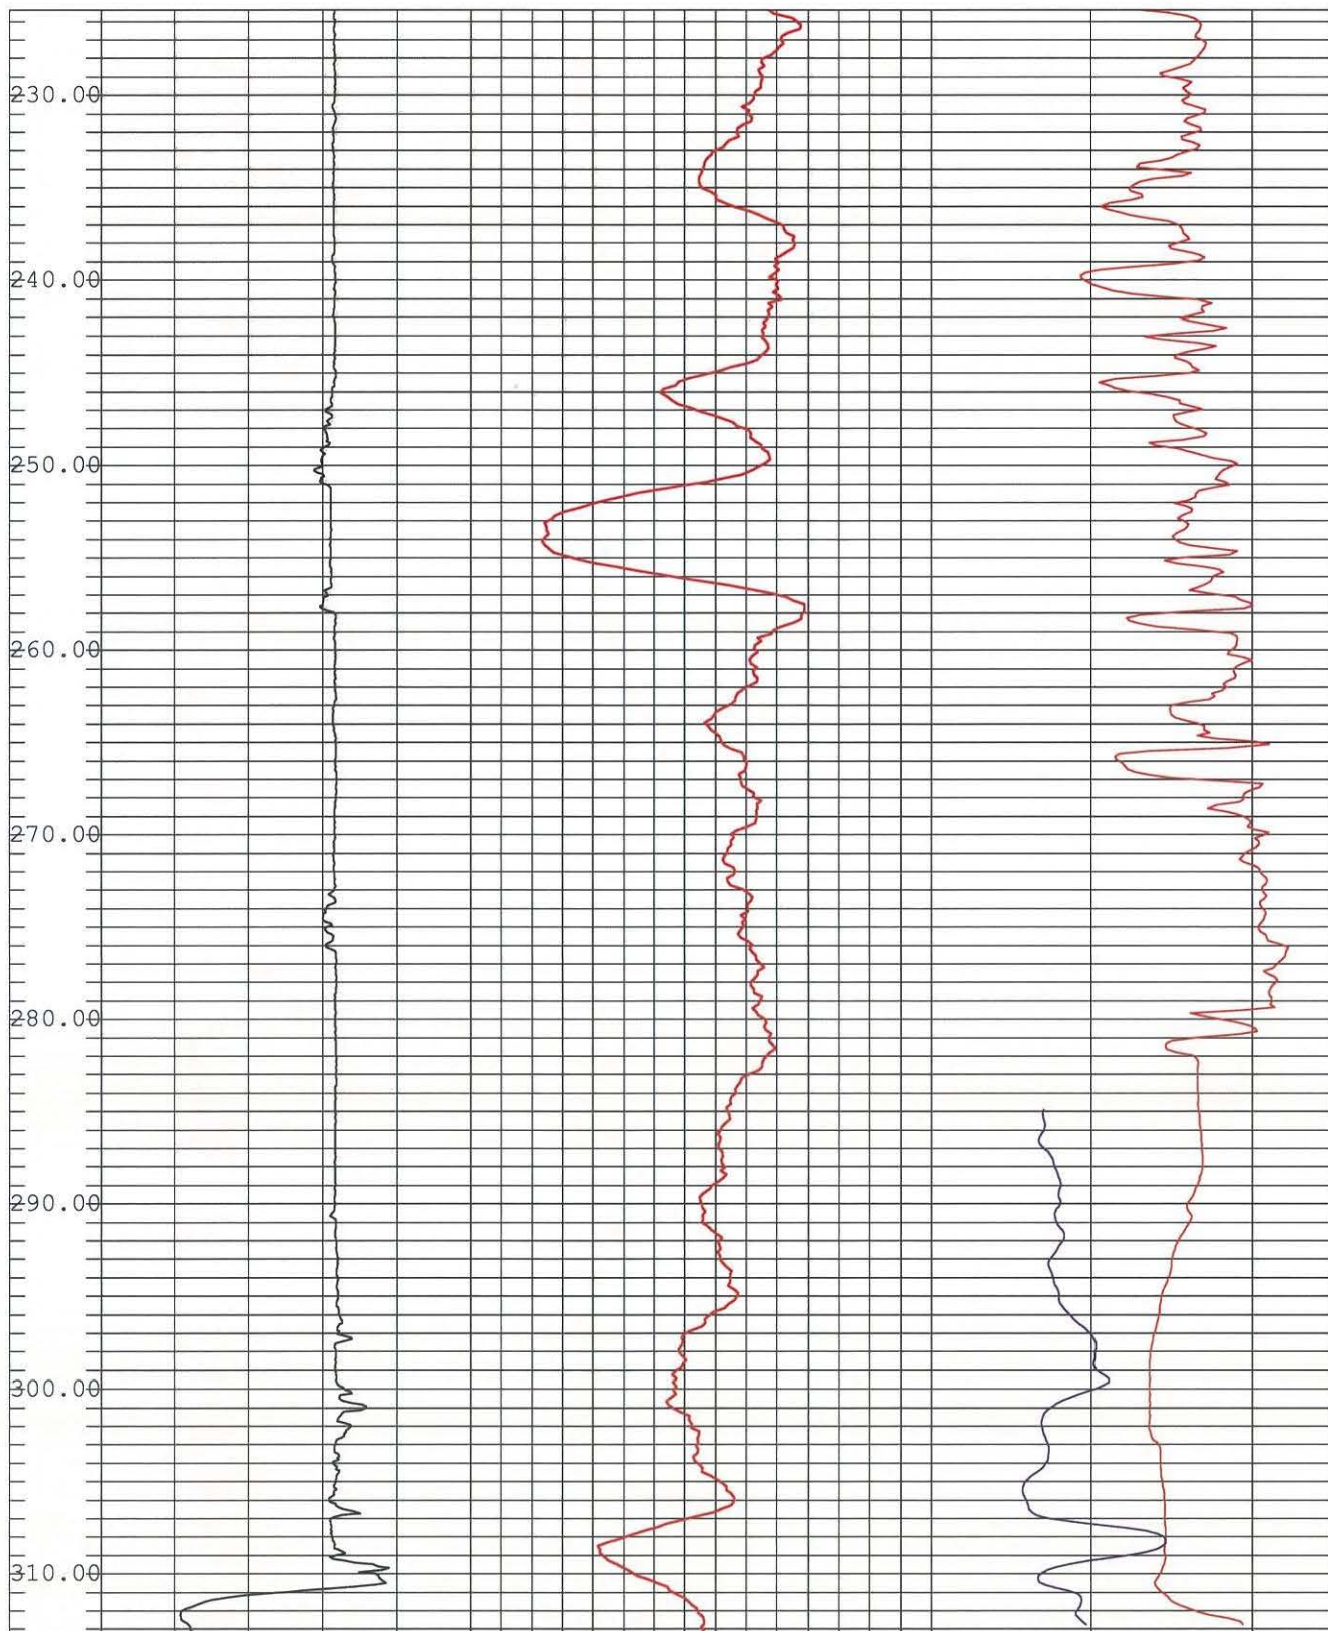
COMPANY: ESTERN NVIRONMENT AND COLOGY, NC	
		Location: N40 01.217, W105 01.198	
Well	S29-2		OTHER SERVICES
Date	11/6/06	BH Fluid	Mud
Casing	None		
File Name	S29-2		
Depth Driller	320		
Depth Logger	318		
Logged by:	D. Greeley		
Witness:	B. Partington

S29-2 Sandy clay soil occurred from 0 to 10 feet. Brown to iron stained claystone was drilled from 10 to 35 feet. From 35 feet to 295 feet, light gray to dark gray claystone was penetrated. Circulation was lost at 295 feet. The Columbine "main" seam occurred from 307 to 315 feet. Maximum caliper deflection of 7.8 inches at 309.8 feet was observed. Total depth of the hole was 320 feet. Collapse was complete, with no open voids.

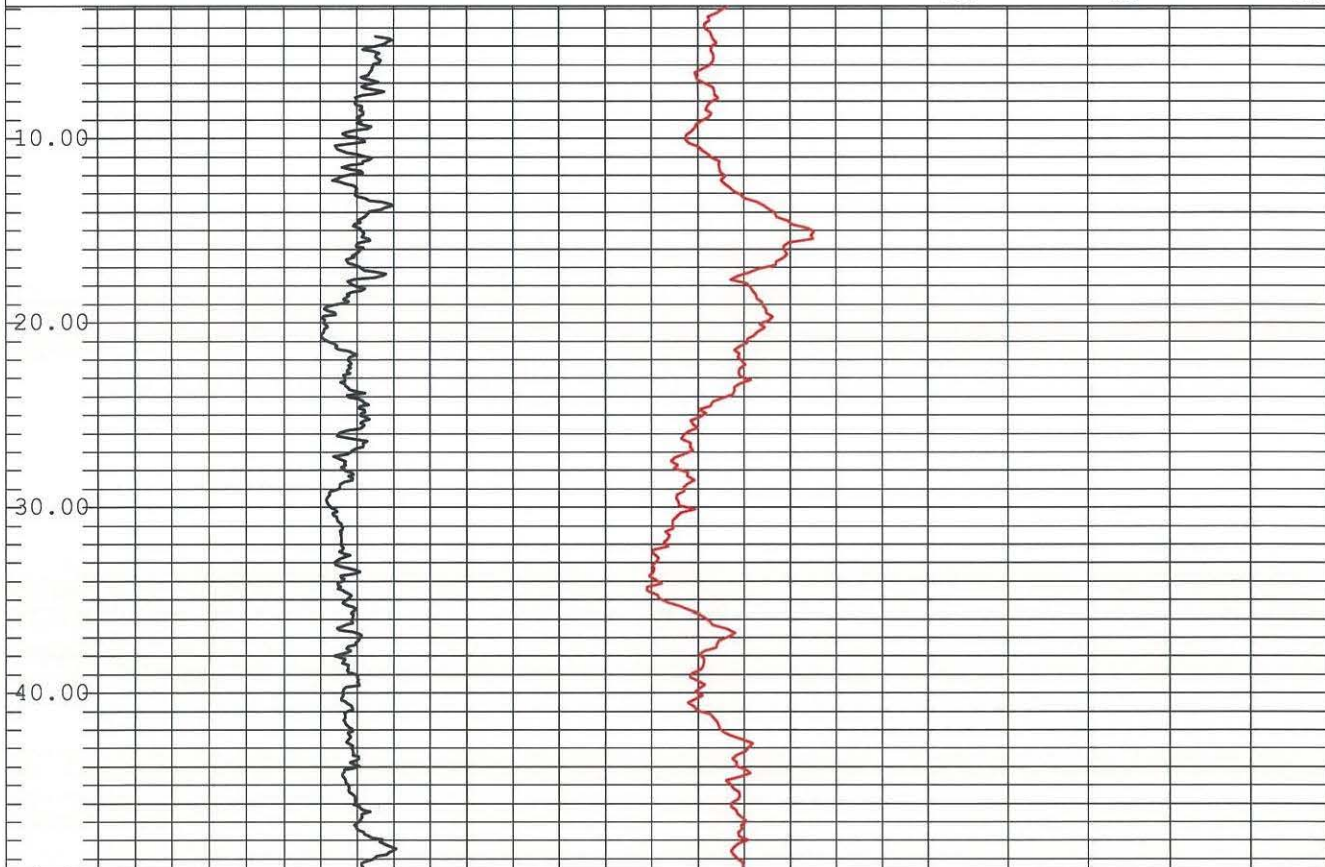
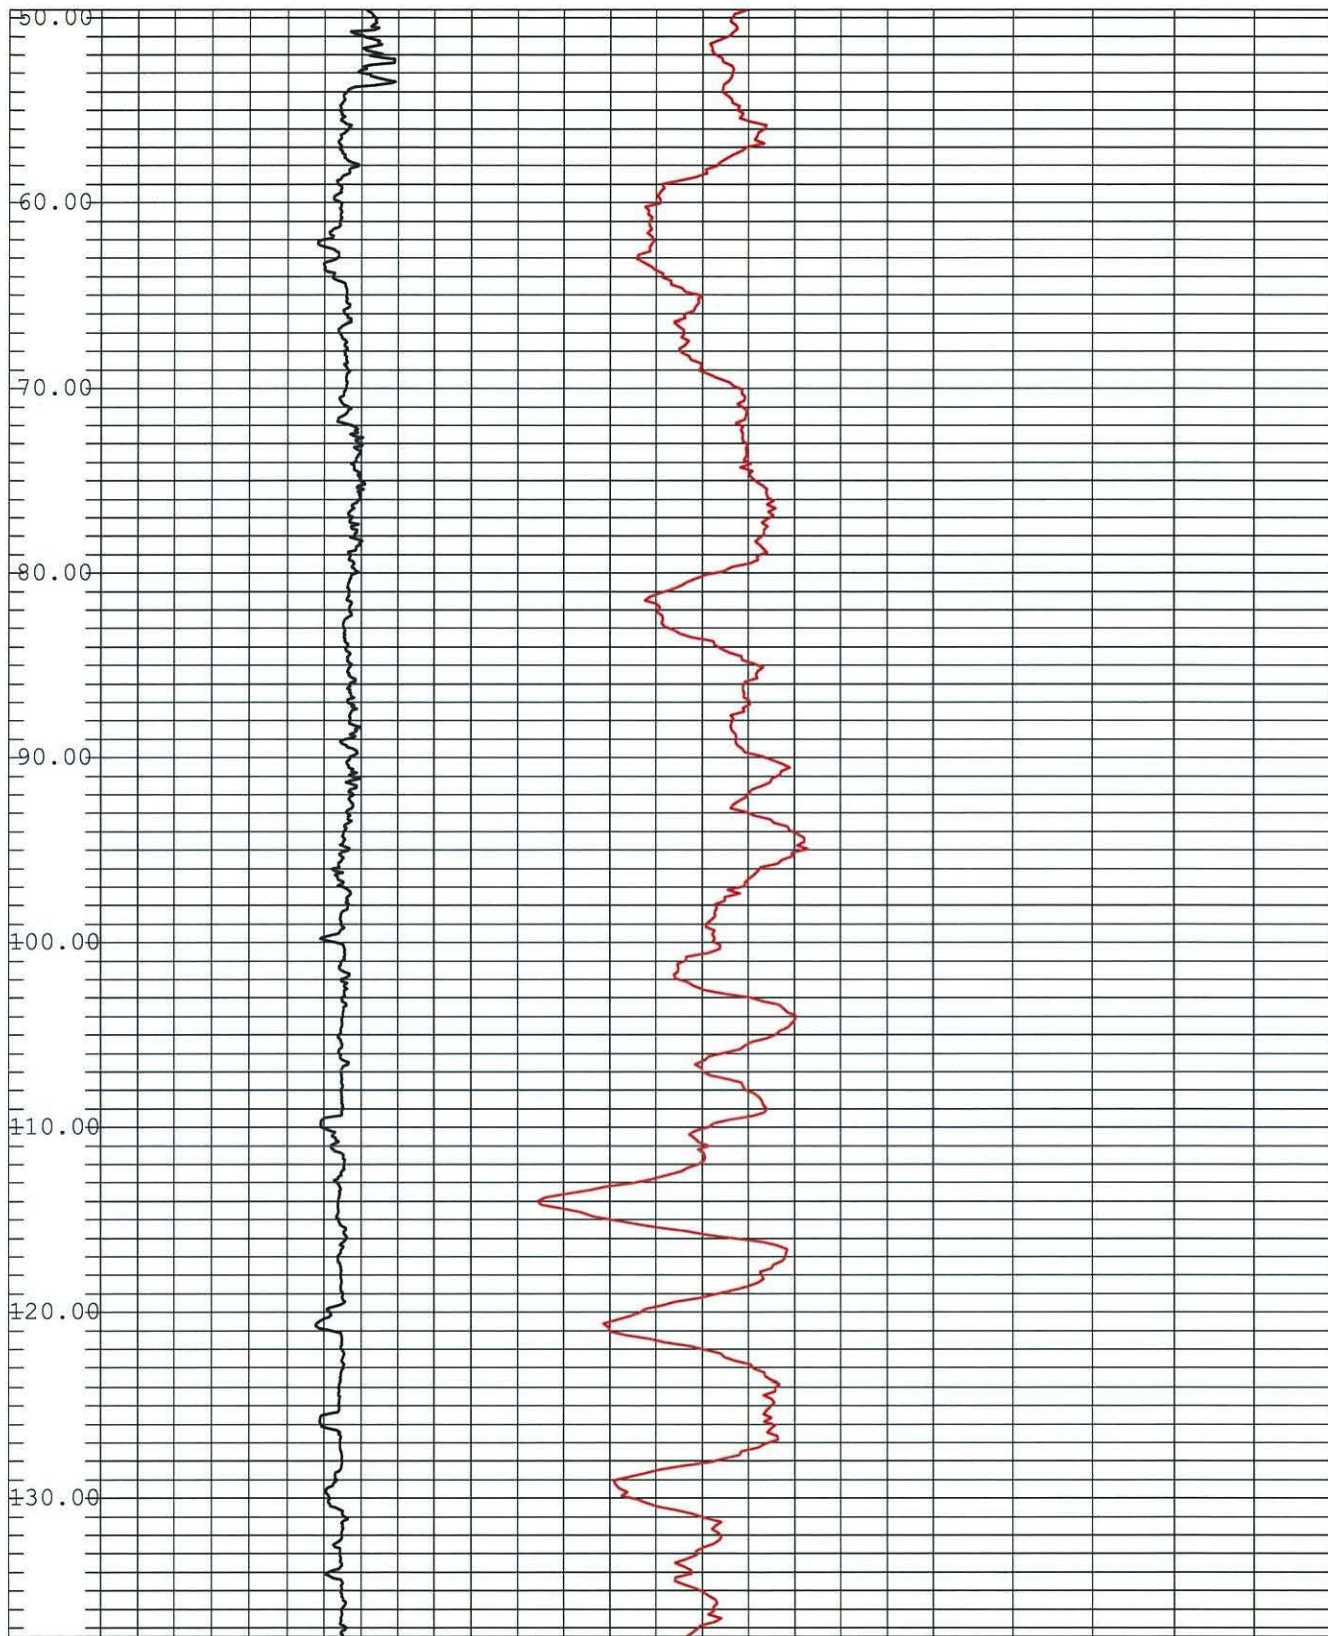
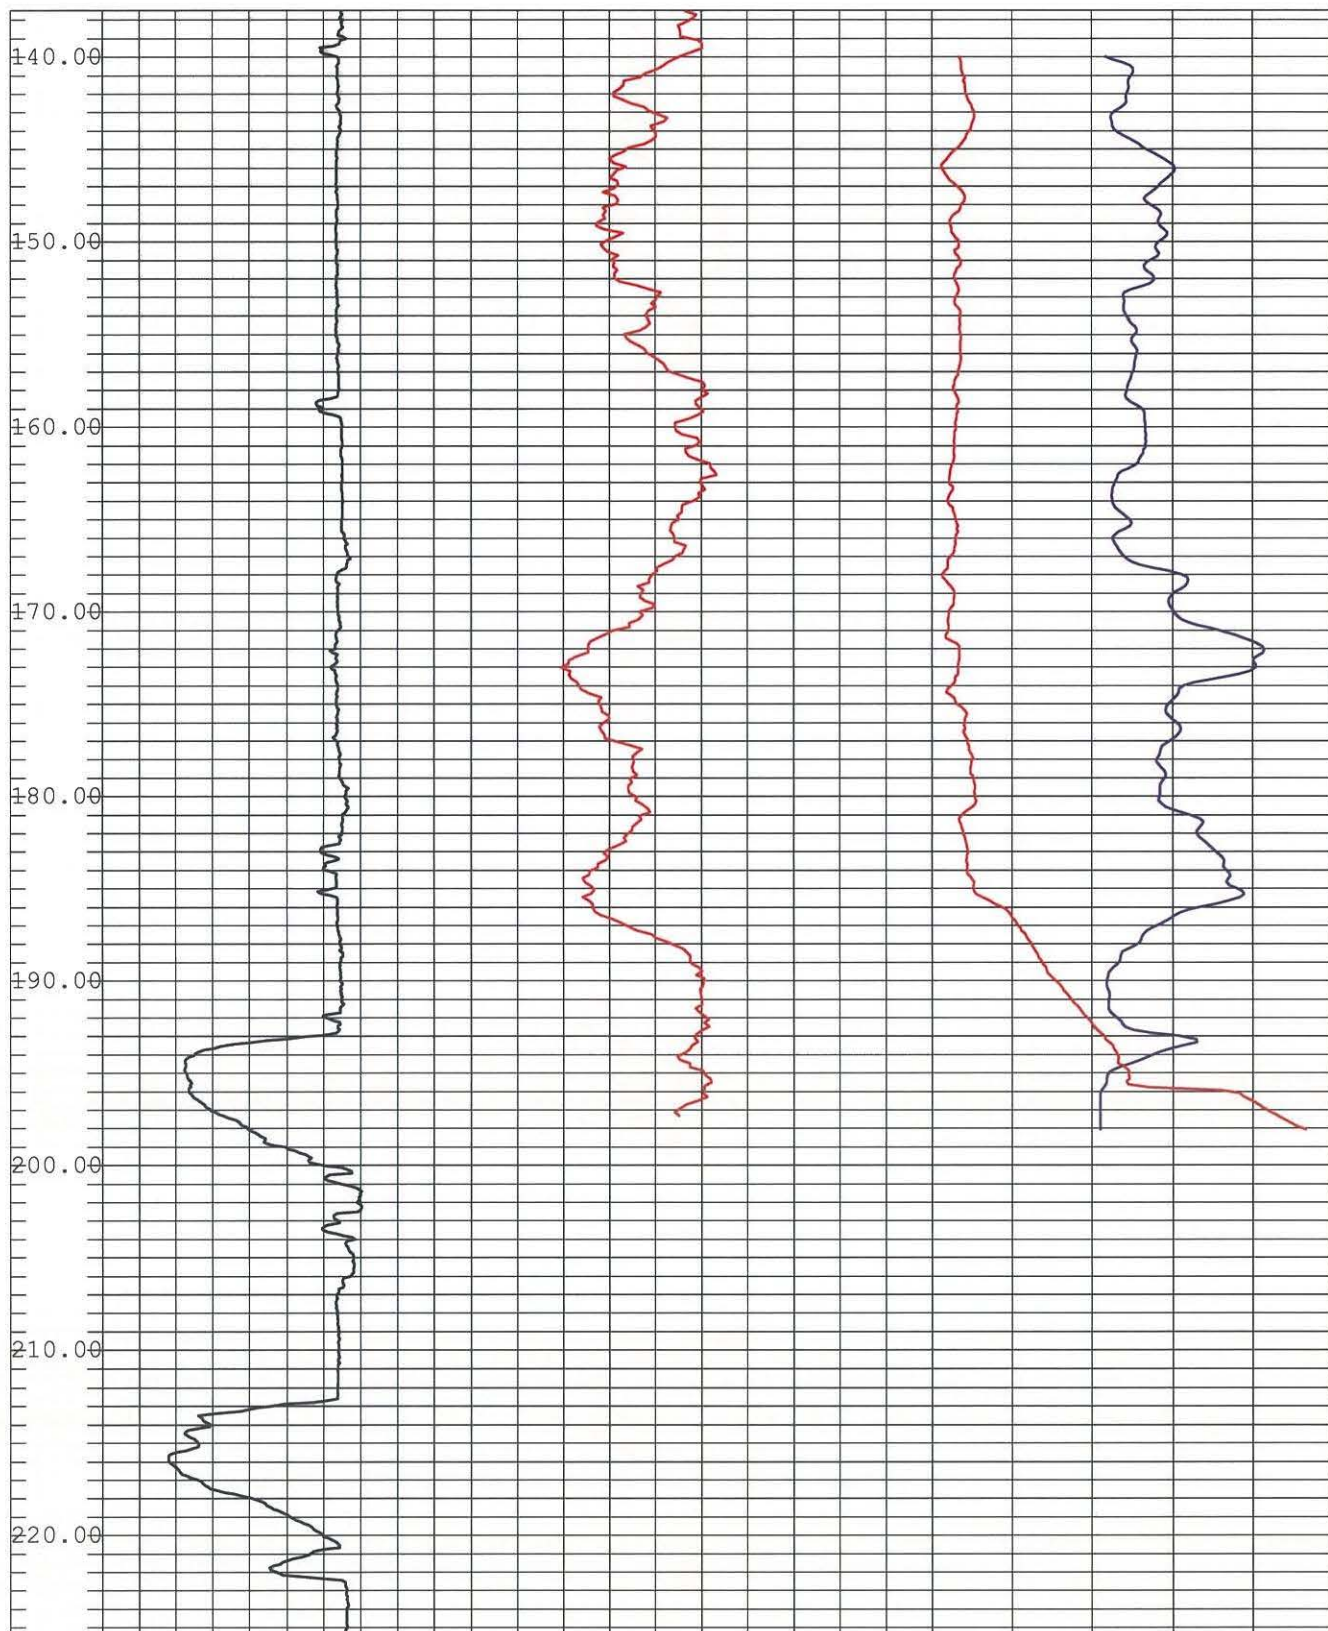
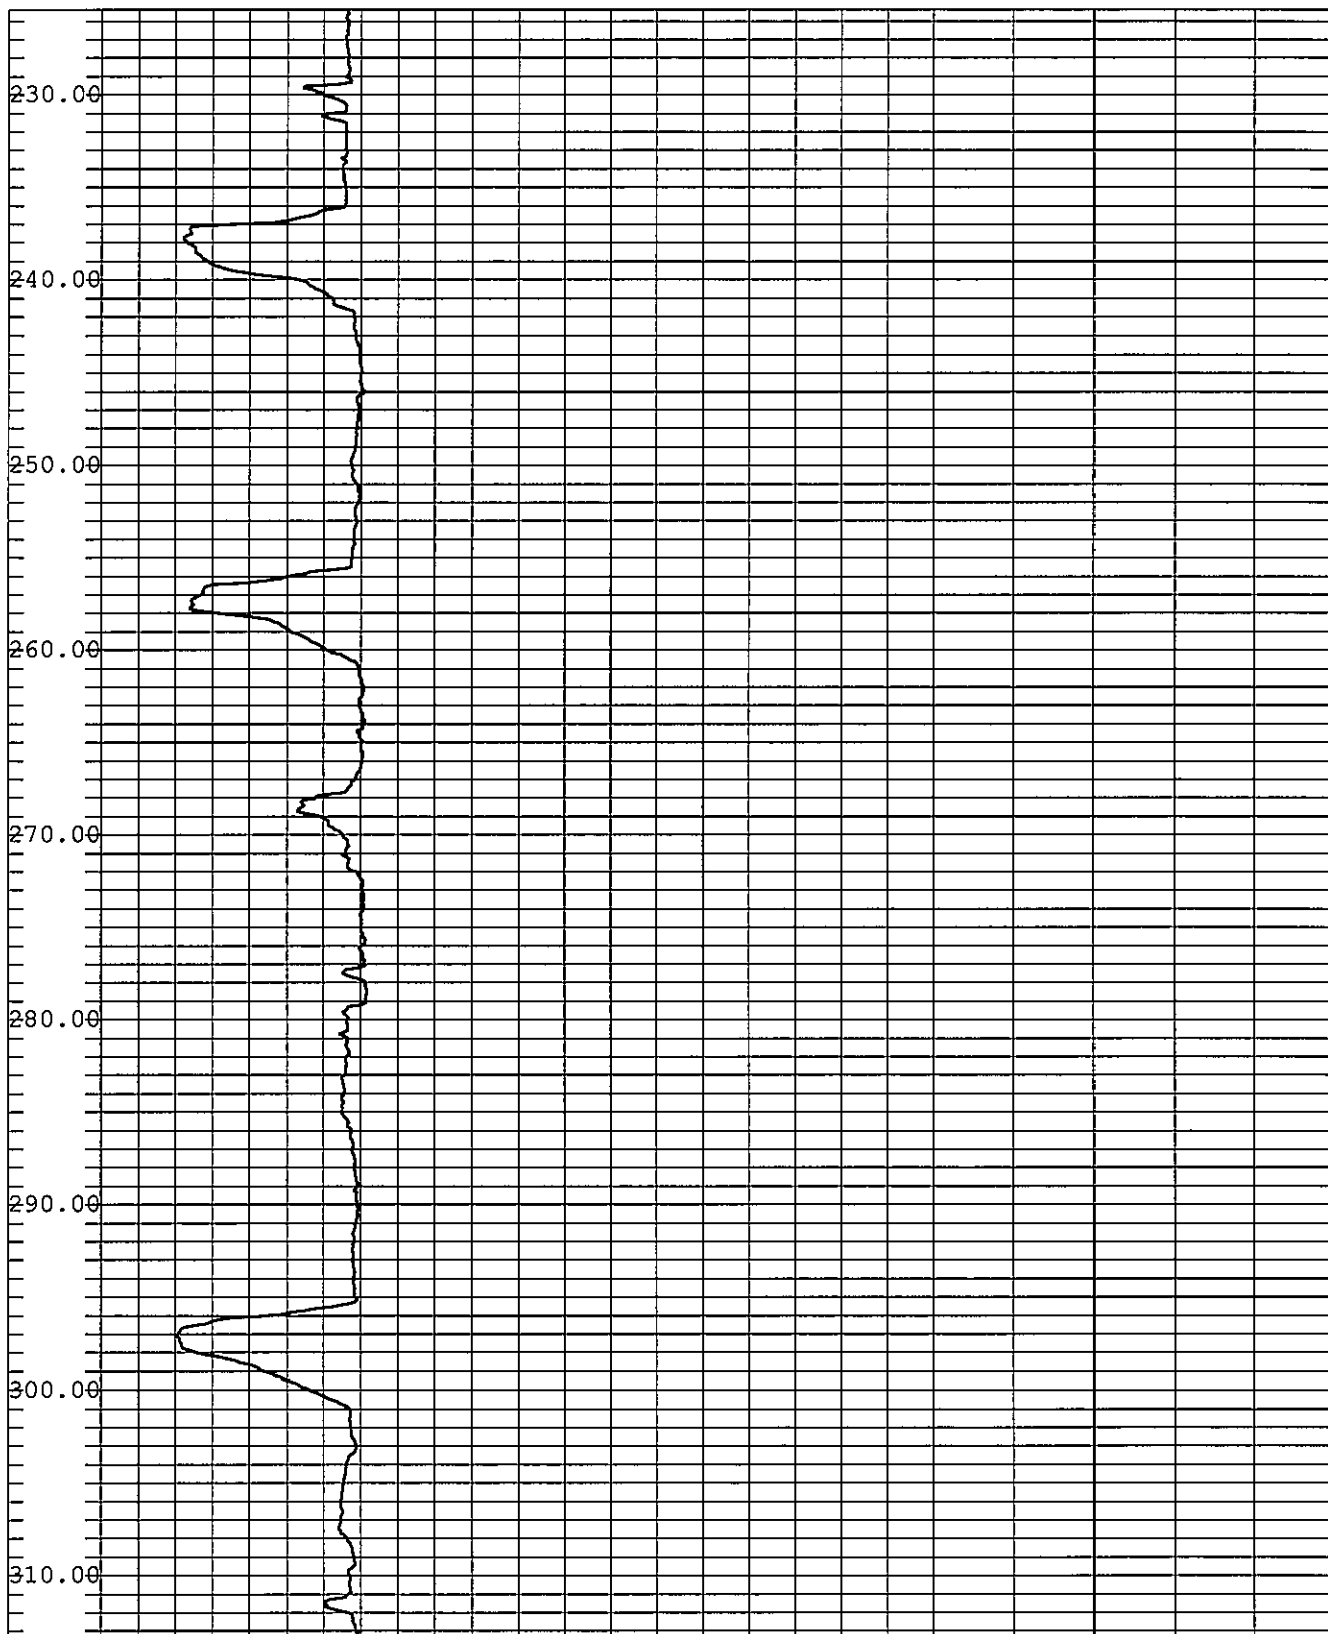
Well	S29-5			OTHER SERVICES
Date	11/7/06	BH Fluid	Mud	
Casing	None			
File Name	S29-5			
Depth Driller	380			
Depth Logger	336			
Logged by:	D. Greeley			
Witness:	B. Partington

S29-5 Sandy clay soil occurred from 0 to 15 feet. Light brown to gray to dark gray claystone with interbedded coal was drilled from 15 to 360 feet. Circulation was not lost. The Columbine "main" seam was penetrated from 267 to 275 feet. Negative caliper deflection was observed at this location. Collapse was complete with no open voids.
